Accurate Inspections

10316 Main
Baton Rouge, LA. 70809

Prepared for: John Doe

Prepared by: Accurate Inspections
10518 Magnolia Lake Ave.
Baton Rouge, La. 70810
Eric Burns....License #10213

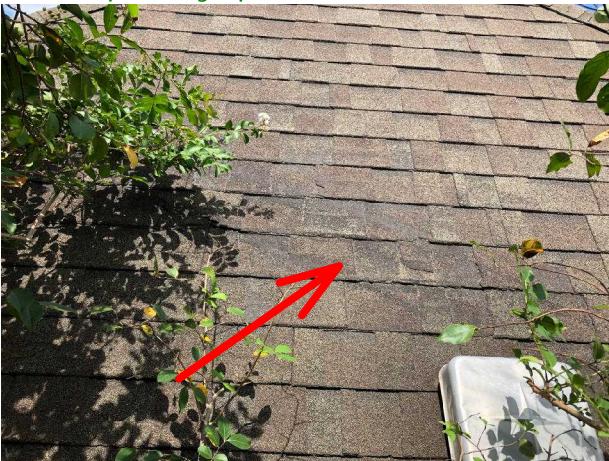
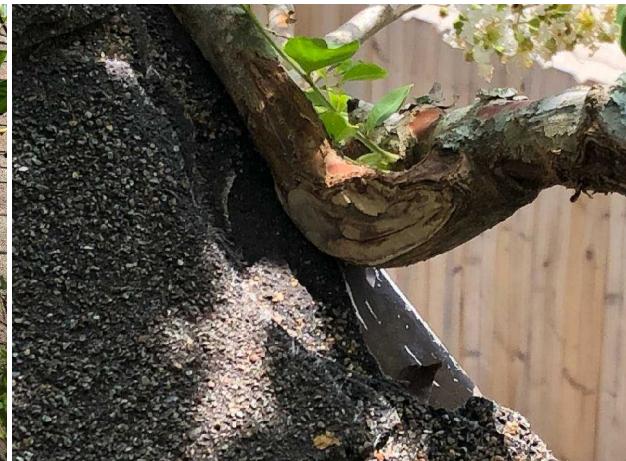
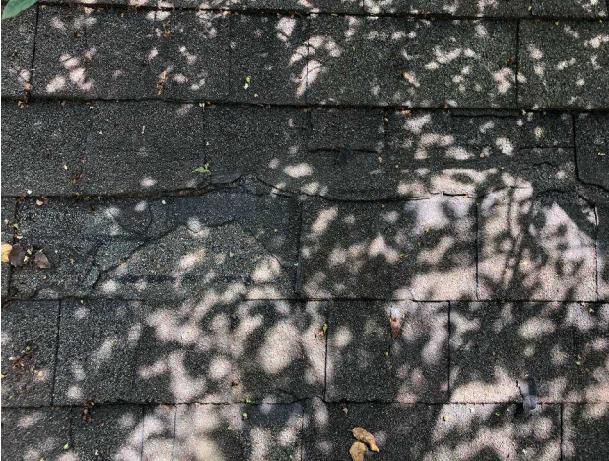
- Walks: Concrete
- Steps/Stoops: Brick
- Patio: Concrete -Rear patio.
- Porch: Concrete -Front porch.
- Vegetation: Tree limbs come in hard contact with the roof in several areas. Notable shingle damage was observed. Recommend tree branch removal, and roof repair by qualified, licensed roofer.

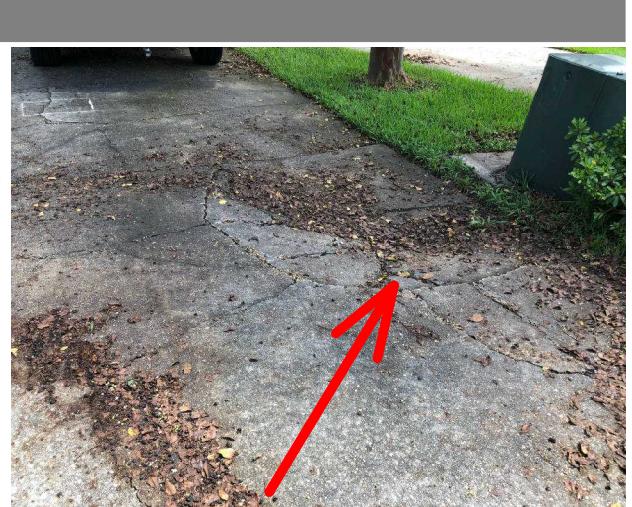
Driveway: Heavy cracking with some vertical displacement was observed on right-hand side of driveway near transformer. Eventually, this area will need to be addressed.

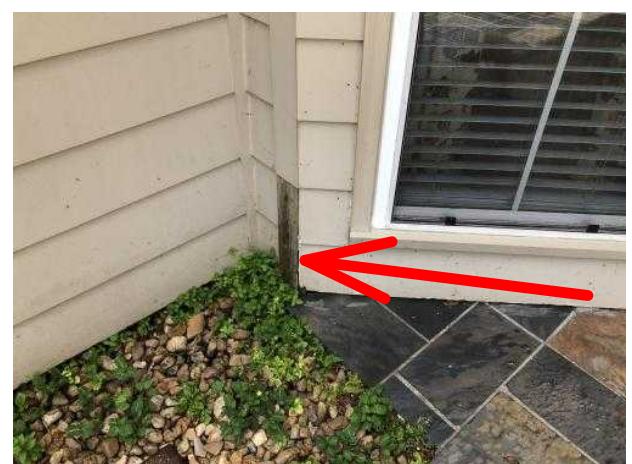
Trim: Complete caulking and painting of vertical wood trim on rear patio.

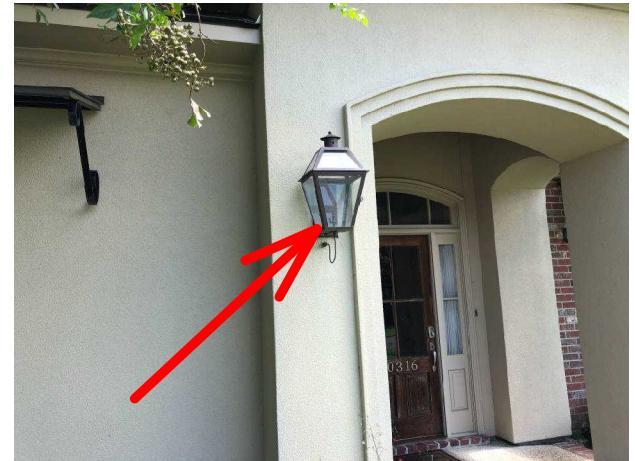
Exterior Lighting: Gas lantern left of front door was not operational. Ensure proper operation before closing.

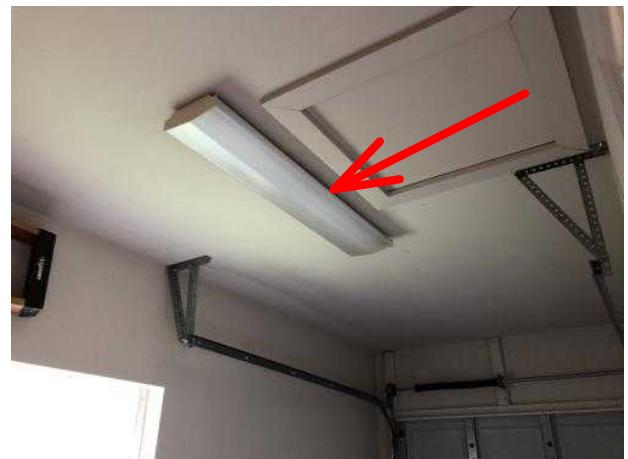
Ceiling: **Florescent light on storage room ceiling works sometimes, and sometimes it doesn't. FYI**

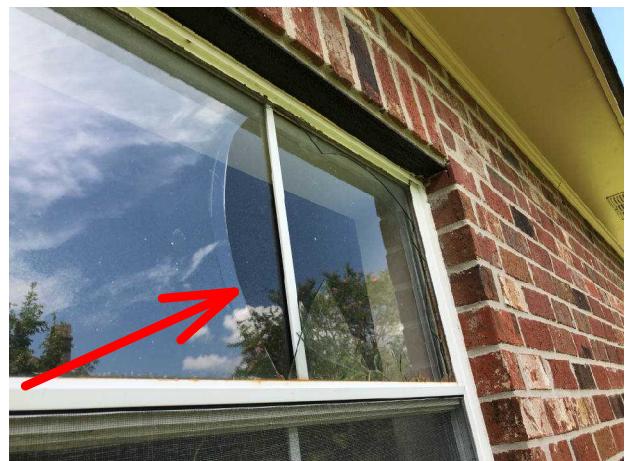
Windows: Outer pane was broken at storage room window.

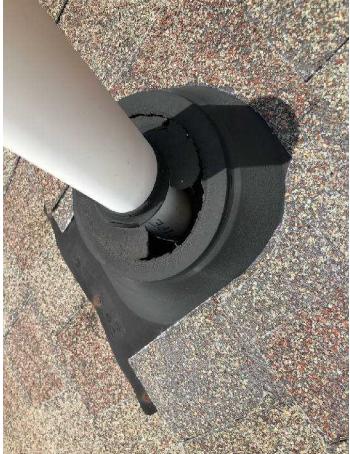
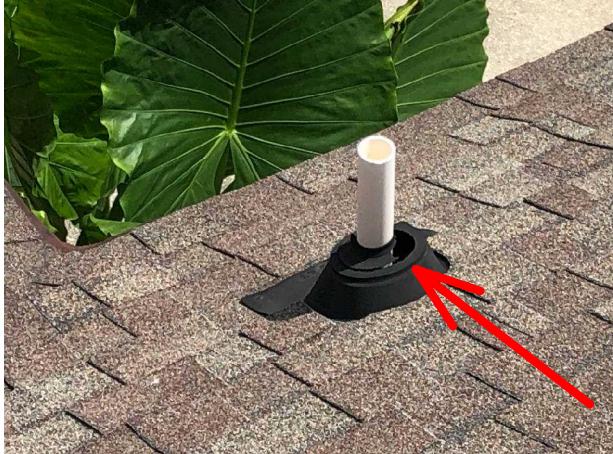
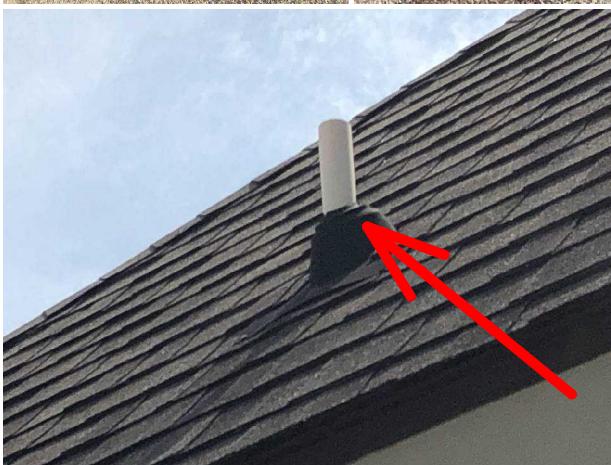
Plumbing Vents: Noted several cracked/dry-rotted rubber "boots" at the plumbing roof vents. Recommend replacement by qualified roofer. (A defective rubber boot will leak rain-water into the attic and should be repaired.)

Plumbing Vents: (continued)

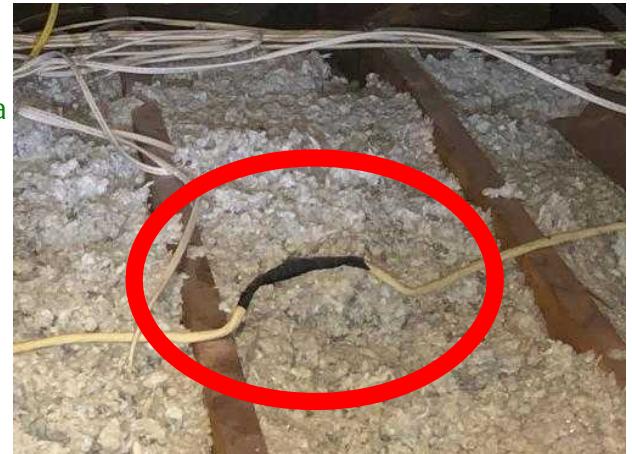
Wiring/Lighting: There was an exposed wire splice noted above living room. Wire splices should be safely concealed within a junction box, and should not be exposed. Recommend repair by licensed electrician.

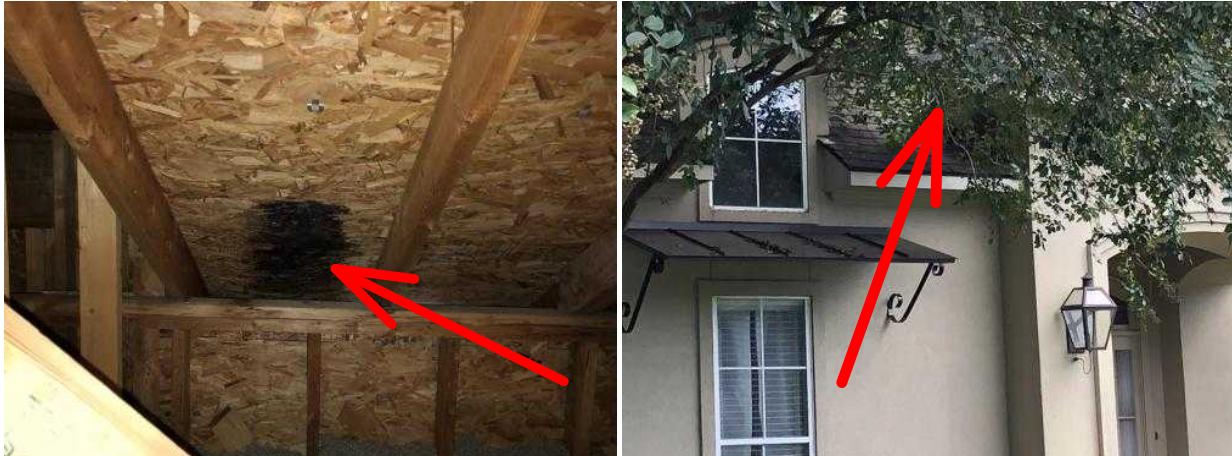
Moisture Penetration: Some rainwater penetration observed at previously noted "defective" plumbing vents.

Also noted roof decking rot/staining on front faade of house right of dormer beneath valley. Recommend further evaluation and repair of these conditions by a qualified, licensed roofer.

Moisture Penetration: (continued)

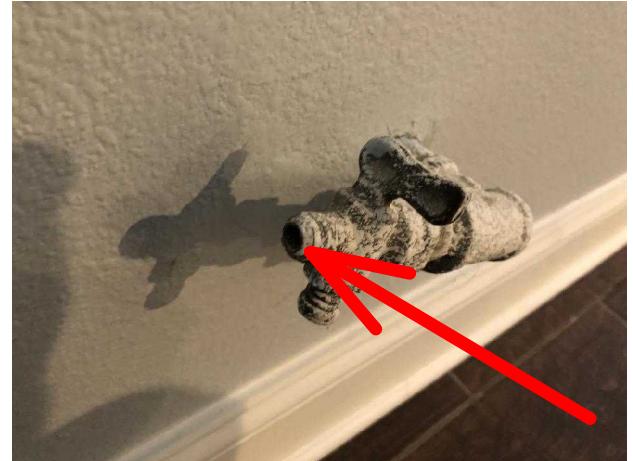
Dryer Gas Line: Gas line should be capped in addition to having an on/off valve for safety reasons. There is no cap present at this time.

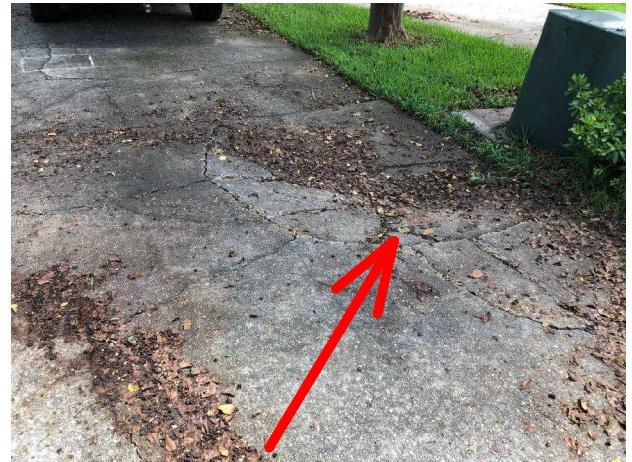
1. Driveway: Heavy cracking with some vertical displacement was observed on right-hand side of driveway near transformer. Eventually, this area will need to be addressed.

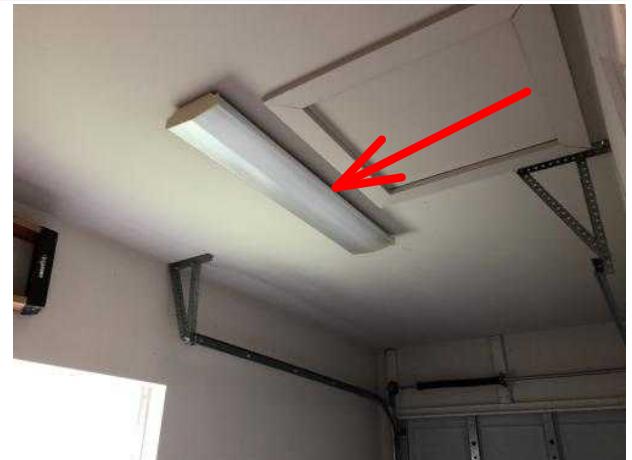
3. Attached Garage Ceiling: Florescent light on storage room ceiling works sometimes, and sometimes it doesn't. FYI

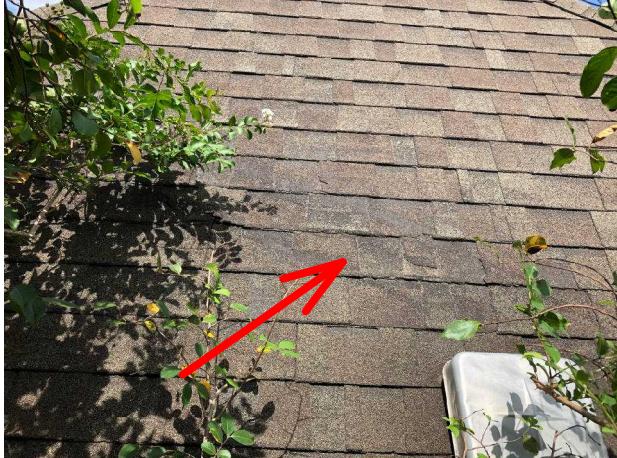
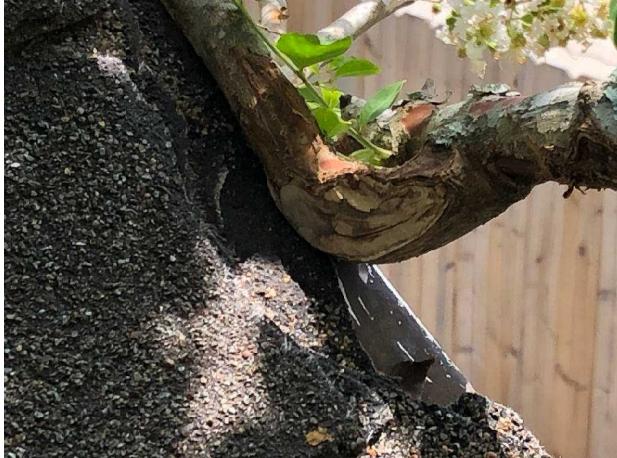
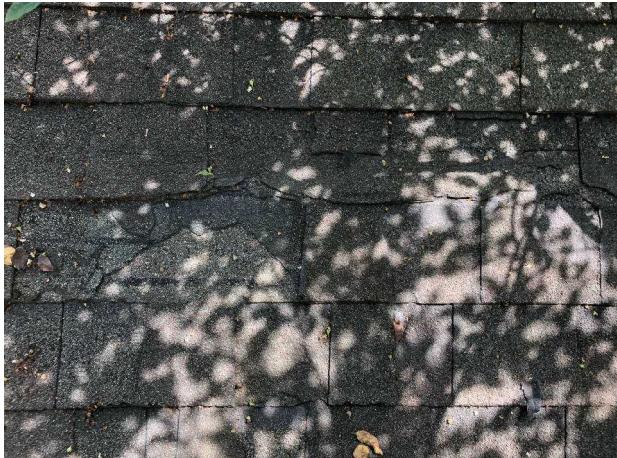
1. Vegetation: Tree limbs come in hard contact with the roof in several areas. Notable shingle damage was observed. Recommend tree branch removal, and roof repair by qualified, licensed roofer.

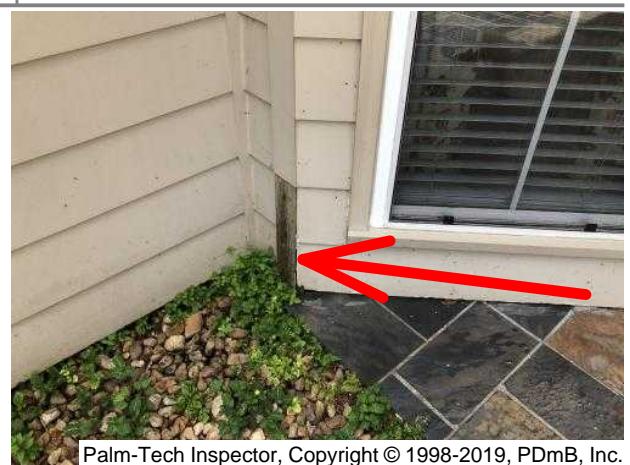
2. Trim: Complete caulking and painting of vertical wood trim on rear patio.

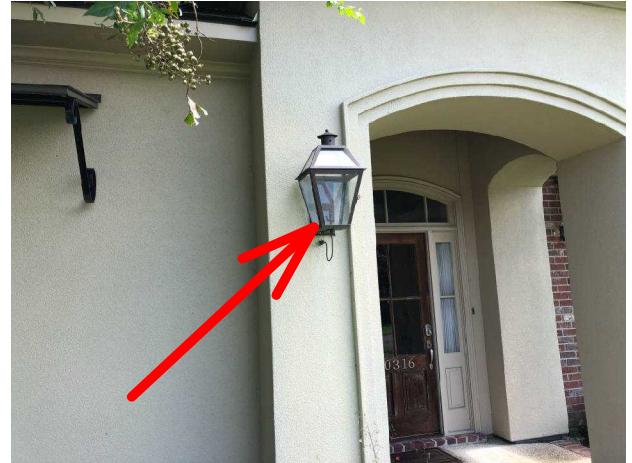
3. Exterior Lighting: Gas lantern left of front door was not operational. Ensure proper operation before closing.

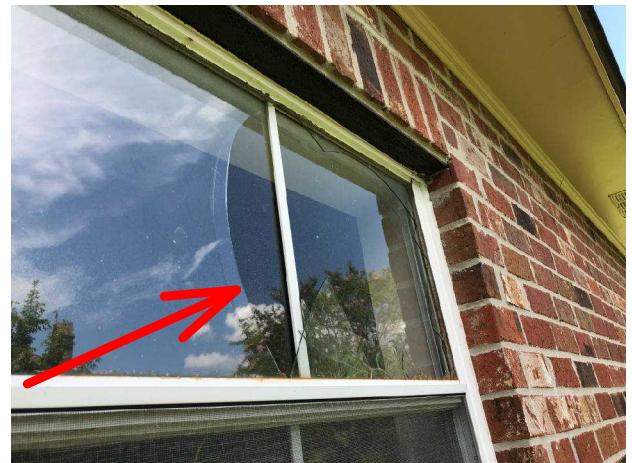
5. Attached Garage Electrical: All electrical outlets in a carport or garage are required to be GFCI protected in a house of this age. These are NOT. Recommend licensed electrician add GFCI protection as required.
6. Attached Garage Windows: Outer pane was broken at storage room window.

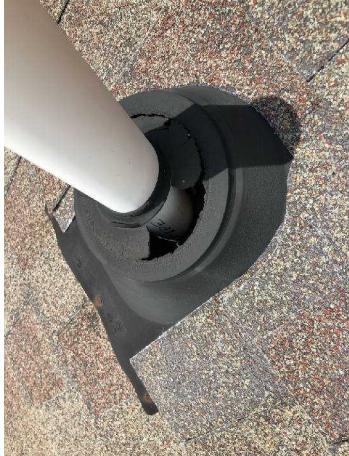
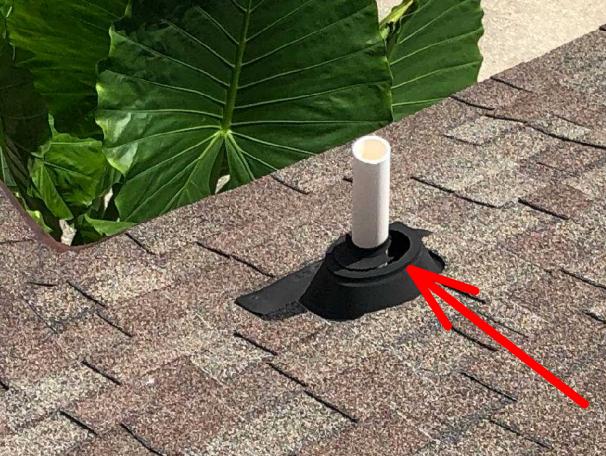
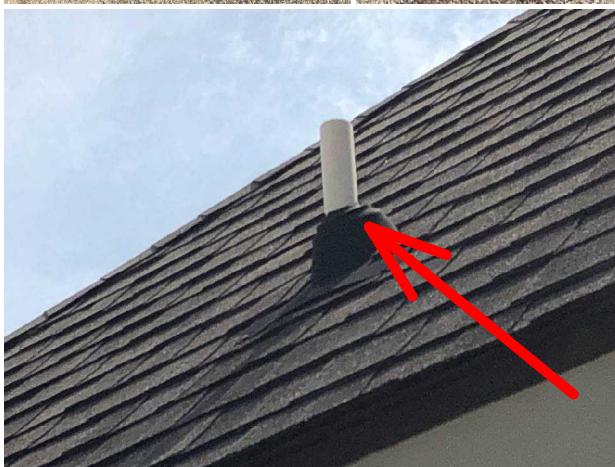
7. Plumbing Vents: Noted several cracked/dry-rotted rubber "boots" at the plumbing roof vents. Recommend replacement by qualified roofer. (A defective rubber boot will leak rain-water into the attic and should be repaired.)

Plumbing Vents: (continued)

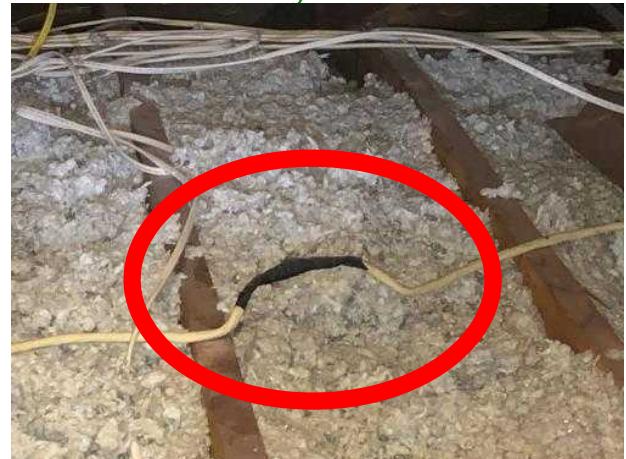
- 8. Main Attic Attic access stairs Stair stringers, treads, and operating arms were in generally very poor condition. Accurate Inspections recommends replacement for the safety of all users.
- 9. Main Attic Wiring/Lighting: There was an exposed wire splice noted above living room. Wire splices should be safely concealed within a junction box, and should not be exposed. Recommend repair by licensed electrician.

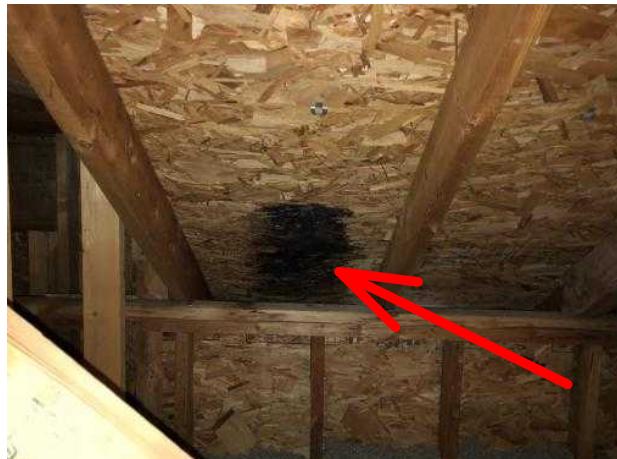
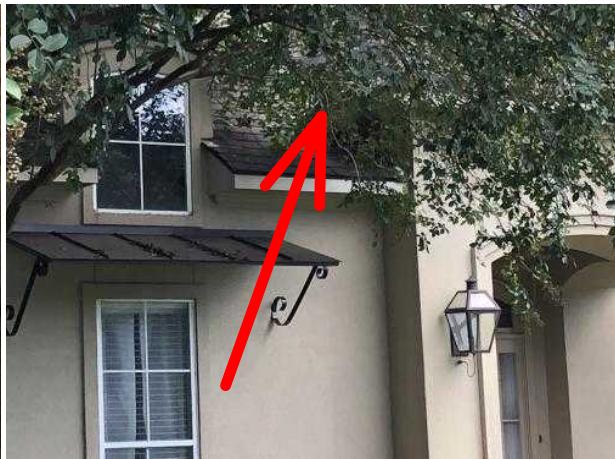
10. Main Attic Moisture Penetration: Some rainwater penetration observed at previously noted "defective" plumbing vents.

Also noted roof decking rot/staining on front faade of house right of dormer beneath valley. Recommend further evaluation and repair of these conditions by a qualified, licensed roofer.

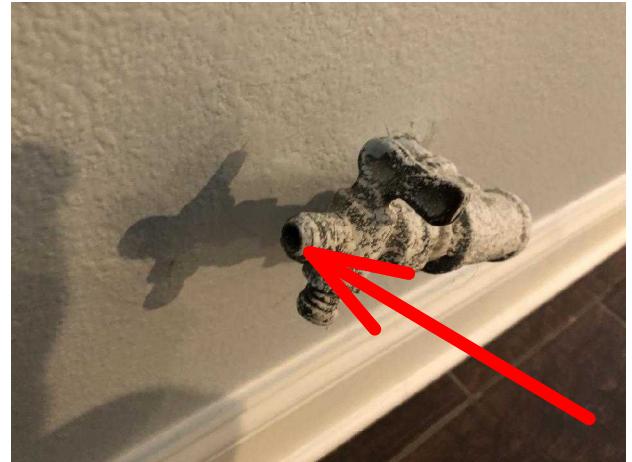
15. Main Laundry Room/Area Dryer Gas Line: **Gas line** should be capped in addition to having an on/off valve for safety reasons. There is no cap present at this time.
